LTPP Seasonal Monitoring Program

**Site Installation and Initial
Data Collection**

**Section 493011
Nephi Utah**

Report No. FHWA-49-3011

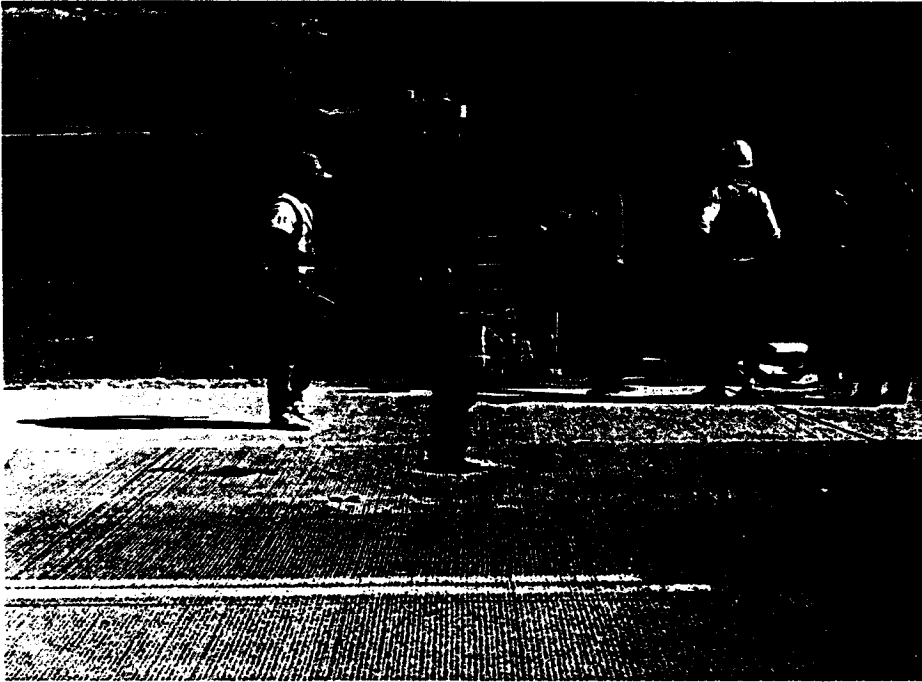
Figure E-3. Completed instrumentation hole and cabinet at the end of day 2.
